THAMES RIVER BASIN
SPRAGUE, CONNECTICUT
VERSAILLES POND DAM
(CT 00472)

PHASE I INSPECTION REPORT
NATIONAL DAM INSPECTION PROGRAM

DEPARTMENT OF THE ARMY
NEW ENGLAND DIVISION, CORPS OF ENGINEERS
WALTHAM, MASS. 02154

AUGUST, 1980

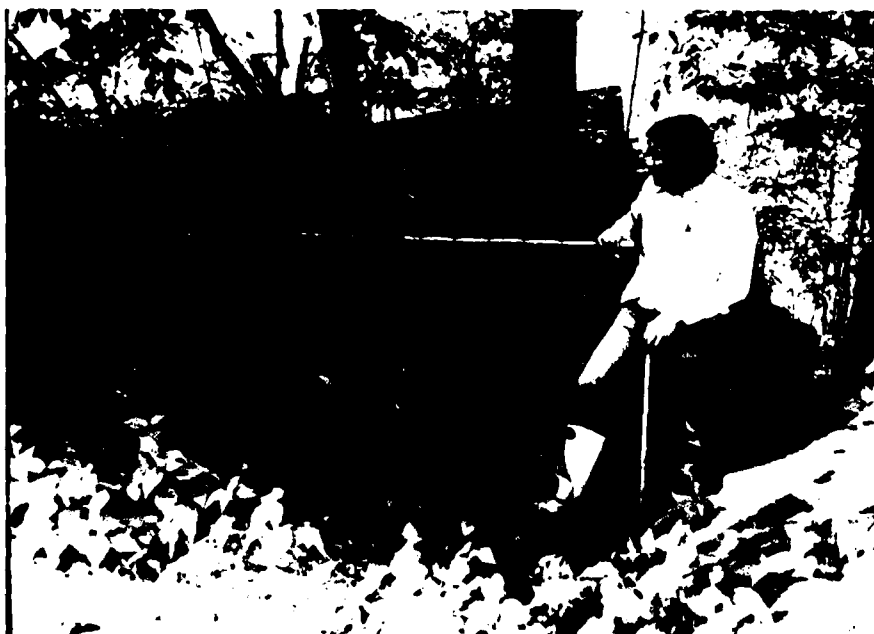
1. The lack of adequate riprap on the upstream slope of the embankment could result in erosion of the slope.
2. The root systems of the large trees on the dam embankment could provide paths for seepage through the dam. Also the trees on the embankment could become uprooted, causing damage to the embankment.
3. The embankment has slightly irregular slopes and top elevation and there is an eroded area on the downstream slope.

Photo 2 - Eroded area on downstream slope of embankment. Fully extended six foot ruler is being held parallel to the axis of the embankment (6/2/80).

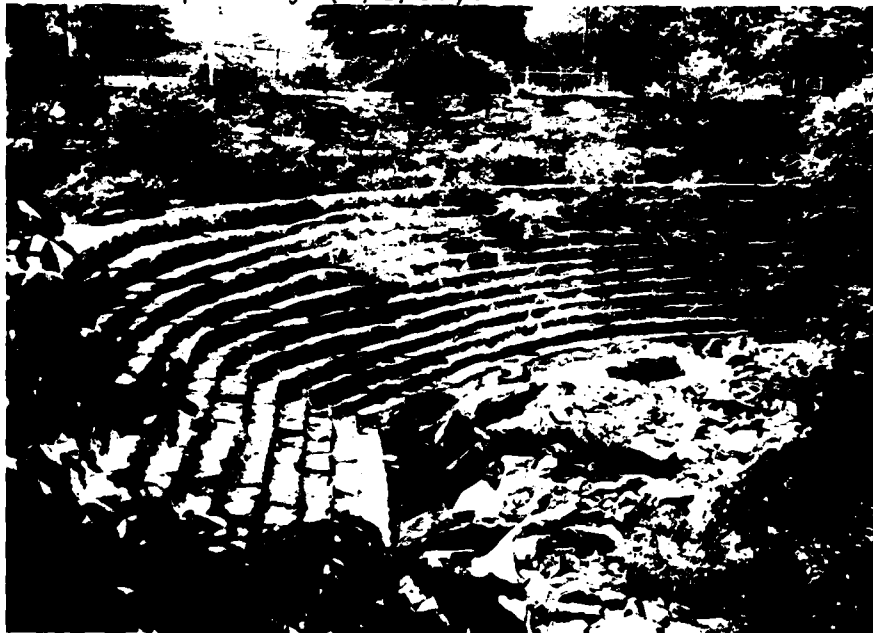
Spillway - The masonry spillway and training walls are in good condition. Some sedimentation of the approach channel has occurred near the right end of the spillway where stoplogs are in place and flow over the spillway only occurs at elevations of one foot or more above the spillway crest. Weedy type vegetation has taken root in these sediments and in sediments along the stoplogs on the curved, left half of the spillway crest (Photo 3). Small woody type vegetation, such as maple saplings, are growing from cracks in the masonry on the stepped downstream face of the left half of the spillway (Photo 4).

Photo 4 - View of spillway from right end. Note riprap displacement at toe and vegetation growth on downstream face (6/2/80).

7. Boulder riprap should be replaced in areas where it is missing at the toe of the spillway.
